2021 TEN YEAR
PLAN
HALIFAX HARBOUR BRIDGES

INTRODUCTION

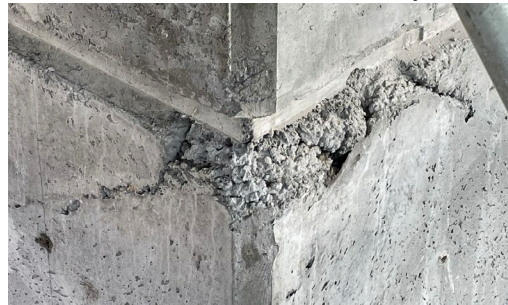
Figure 2 Honeycombing present on Pier D4 from T2021-Q

- Remediation tactics consist of the installation of epoxy grout into drill injection holes, and patch work to combat deficiencies like honeycombing.

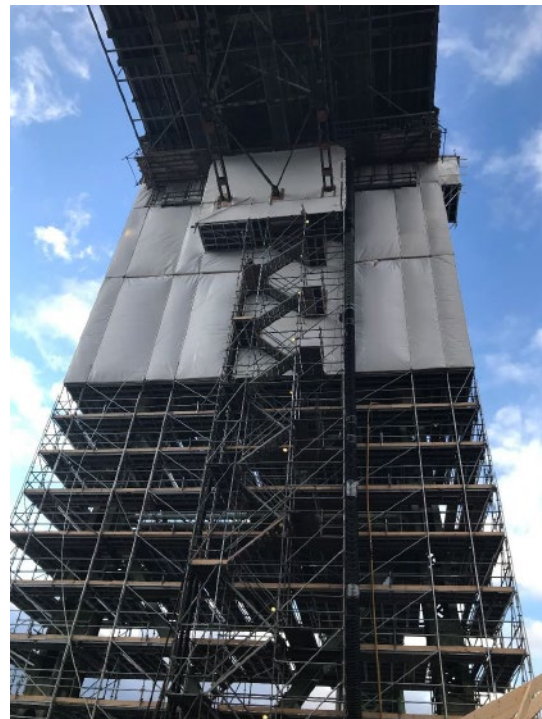
- i. Full Site Containment
 - For on-going works at the Dartmouth Cable Bent, the entire work-zone has been enclosed in tents, and sealed to the outside (As seen in Fig to the right)
- ii. Special Access
 - These enclosures require special permissions to access.
 - You require proper training, and appropriate PPE. (Respirator, enclosed suit, etc.)
- iii. Environmental Controls
 - Considering the environment is a key principal to this project. When blasting the existing coatings, the

lead contained in the paint can become airborne. There are air quality monitoring procedures in place as to mitigate the air pollution, and to ensure the enclosures are working appropriately.
